In-Plant Corrosion Testing in Ozone Bleaching Environments

Pekka Pohjanne – VTT Industrial Systems, P.O.Box 1704, FIN-02044 VTT, Finland

Marko Siltala – UPM-Kymmene, Pulp Center, P.O.Box 42, FIN-68601 Pietarsaari, Finland

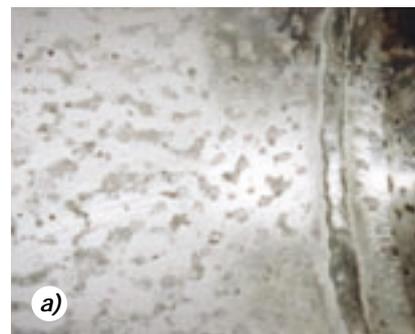
Fig 4. The AISI316L fixture pipe after the exposure tests in ozone feed gas line: a) Corrosion pits and wormeaten looking marks observed on the inner surface and b) SEM figure from a bottom of corrosion pit.

The AISI 316L type tests racks and the fixture pipe had suffered from intense localized corrosion. Corrosion was observed both in the base materials and in the welds. The size of the corrosion pits varied from 1 to 5 mm in diameter and from 0.4 to 0.7 mm in depth. In addition to pits the surfaces were covered with marks that looked like wormholes (Fig. 4a). The appearance of the pits was not typical of pitting corrosion. The bottoms of the pits were rather typical of intergranular corrosion (Fig. 4b).

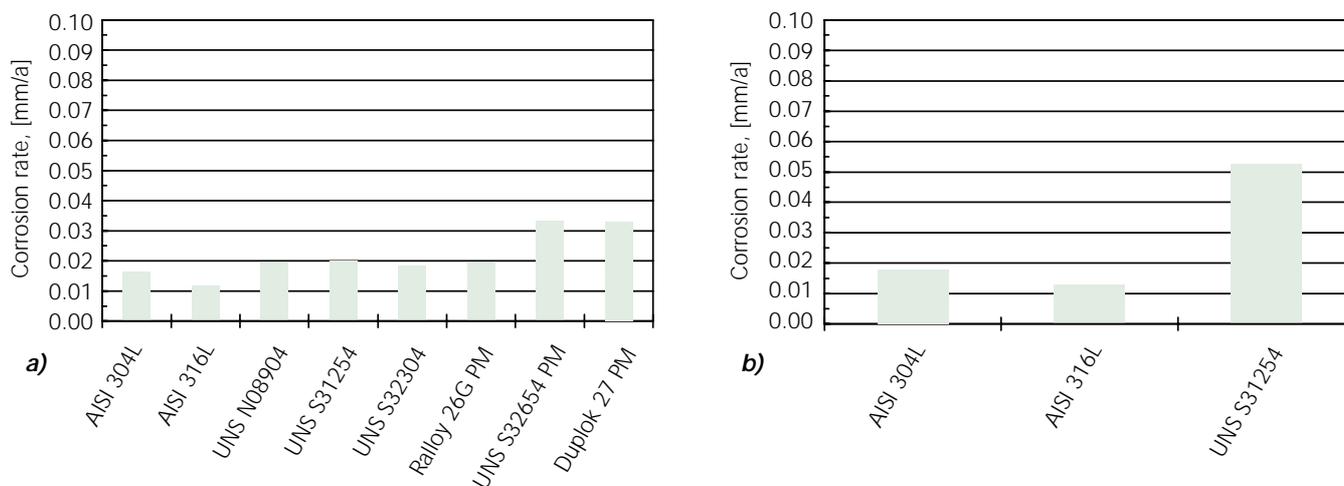
Fig 5. Corrosion rate of different stainless steel grades in ozone gas feed line environment: a) unwelded base materials and b) welded stainless steels.

small (Fig. 5a). Highest corrosion rates, around 0,035 mm/a, were determined for the highly alloyed UNS S32654 PM and Duplok 27 PM steels. All specimens were covered with similar intergranular corrosion pits as observed in the test racks. An exception was the UNS S32654 PM steel which surface was uniformly corroded with a mechanism of transpassive dissolution (Fig 6a).

The corrosion rates of welded AISI 304L and AISI 316L were at the same order with the unwelded base materials specimens (Fig. 5b). The corrosion rate of SMAW weld of UNS S31254 steel was two

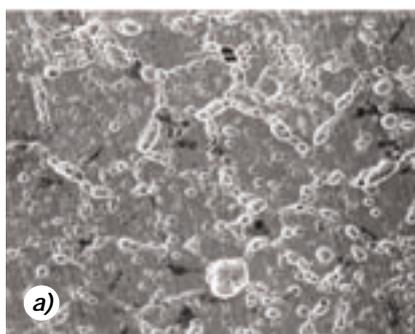
Fig 6. Examples of observed steel surfaces after the exposure tests in ozone feed gas line: a) transpassive dissolution in the UNS S32654 PM and b) selective corrosion in the weld of the UNS S31254.

The ozone gas feed line environment ($T = 20\text{--}30^\circ\text{C}$, pressure 10 bar, O_3 -content = 9.5%) was very corrosive to all stainless steels examined. All materials were subject to intensive general and intergranular corrosion. Highest corrosion rates were determined for the welded UNS S31254 stainless steel. The highly alloyed UNS S32654 stainless steel had second highest corrosion rate.

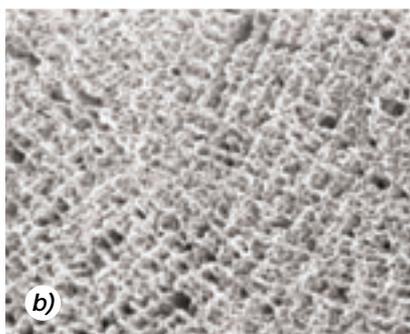
times higher than the un-welded specimen. Metallographic examination revealed that the welds and fusion lines had partially selectively corroded, revealing the dendrite structure. Selective corrosion was most intense in the nickel base weld of the UNS S31254 (Fig. 6b).
